INDOOR AIR QUALITY ASSESSMENT

**Roxbury District Court
85 Warren Street
Boston, Massachusetts**

Prepared by:
Massachusetts Department of Public Health
Center for Environmental Health
Emergency Response/Indoor Air Quality Program
April 2006

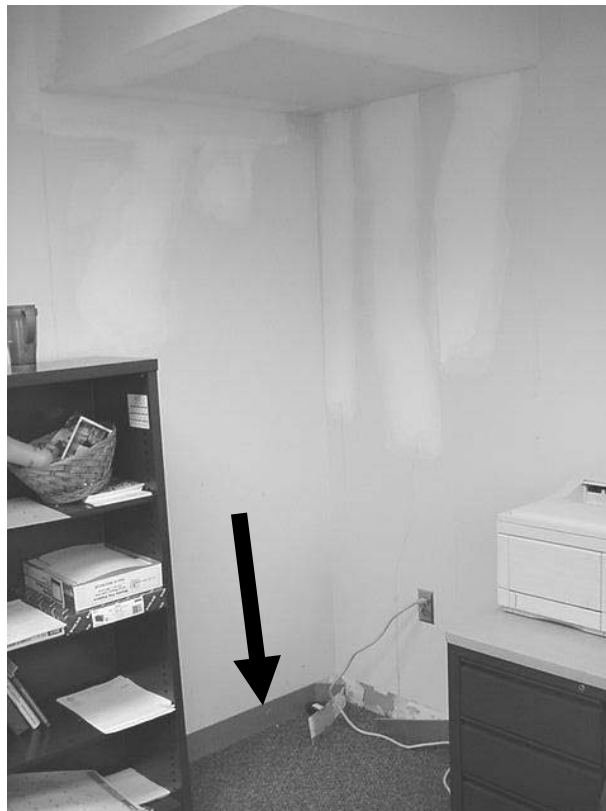
Picture 8

Vinyl Coving Removed Beneath Area of Flooding in Room 314

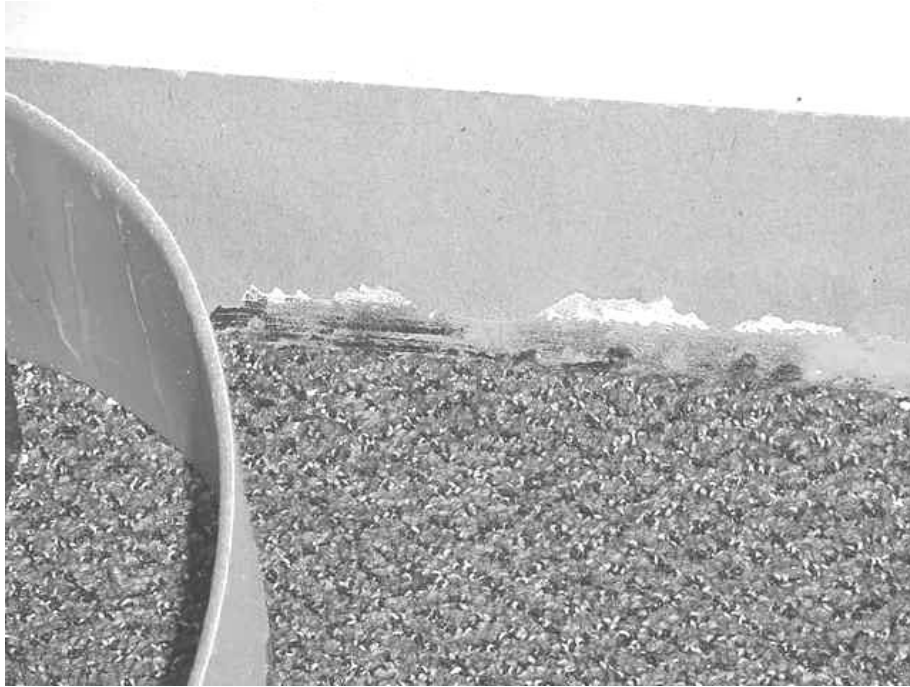
Picture 9

Visible Mold Growth (as Indicated by Dark Stains at Base of Wall) on Surface of Gypsum Wallboard behind Vinyl Coving in Room 314

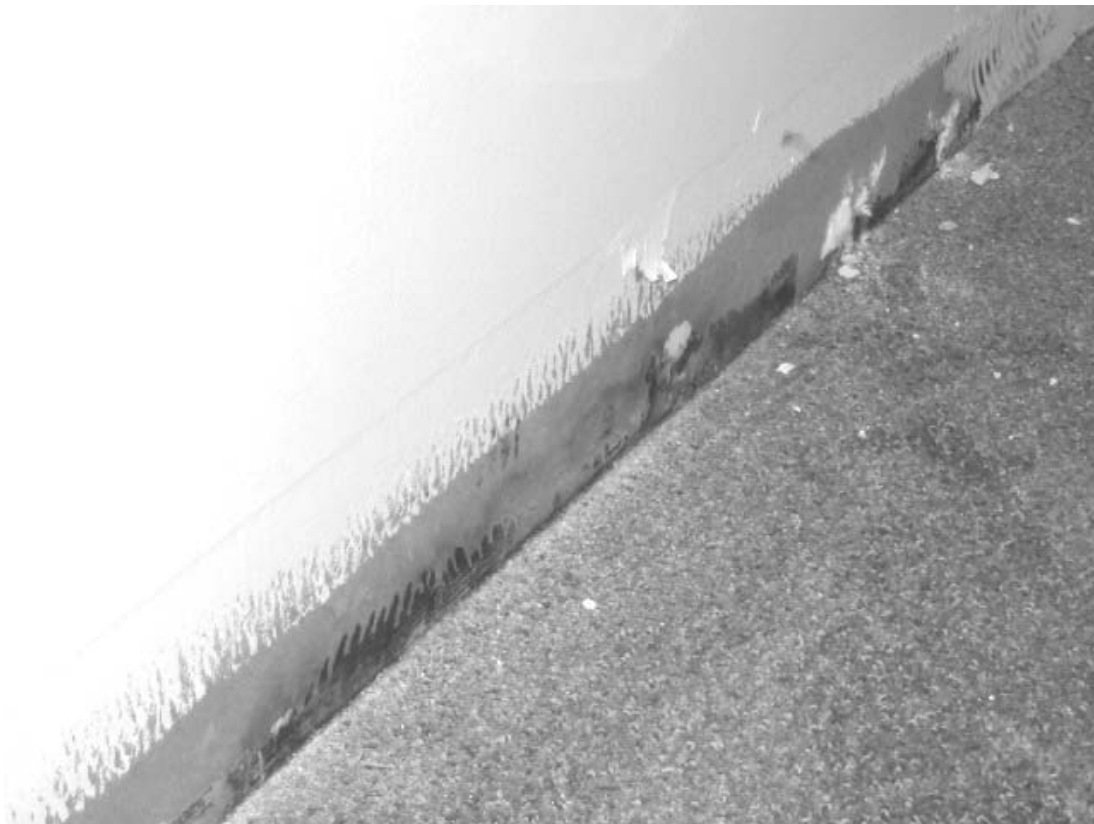
Picture 10

Mold Colonized GW in Store Room as Indicated by Dark Staining along Base

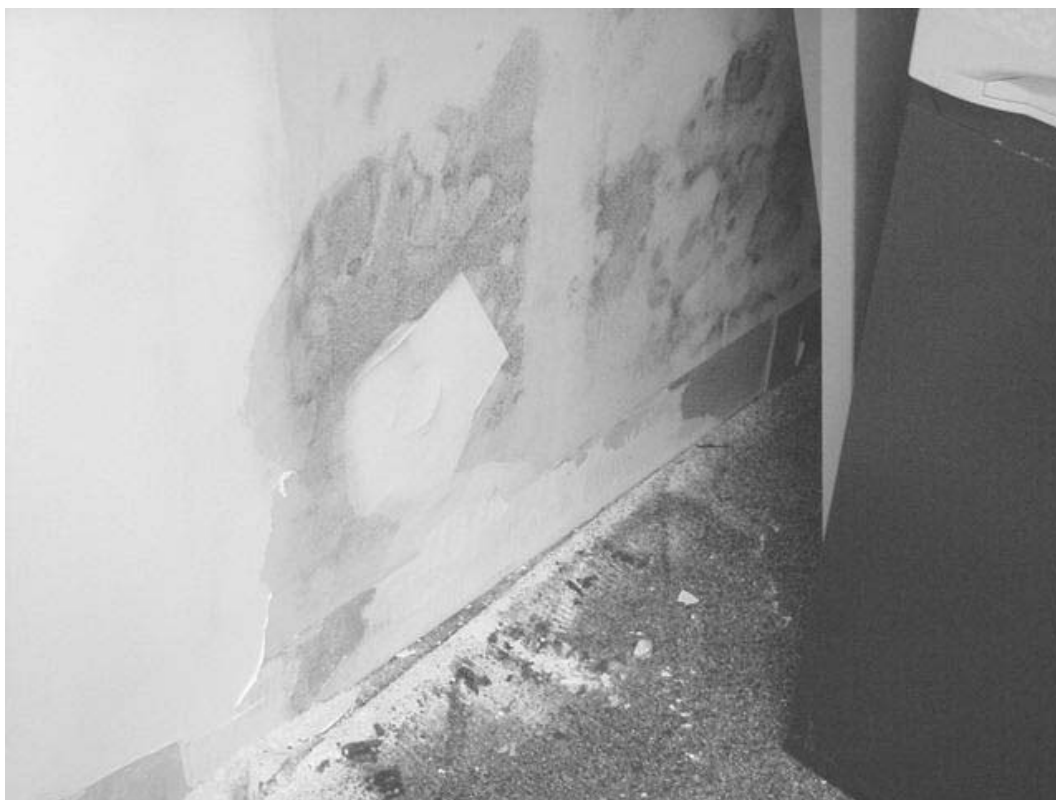
Picture 11

Visible Mold Growth (as Indicated by Dark Stains) on Painted Surface of Gypsum Wallboard in Central Storage Room

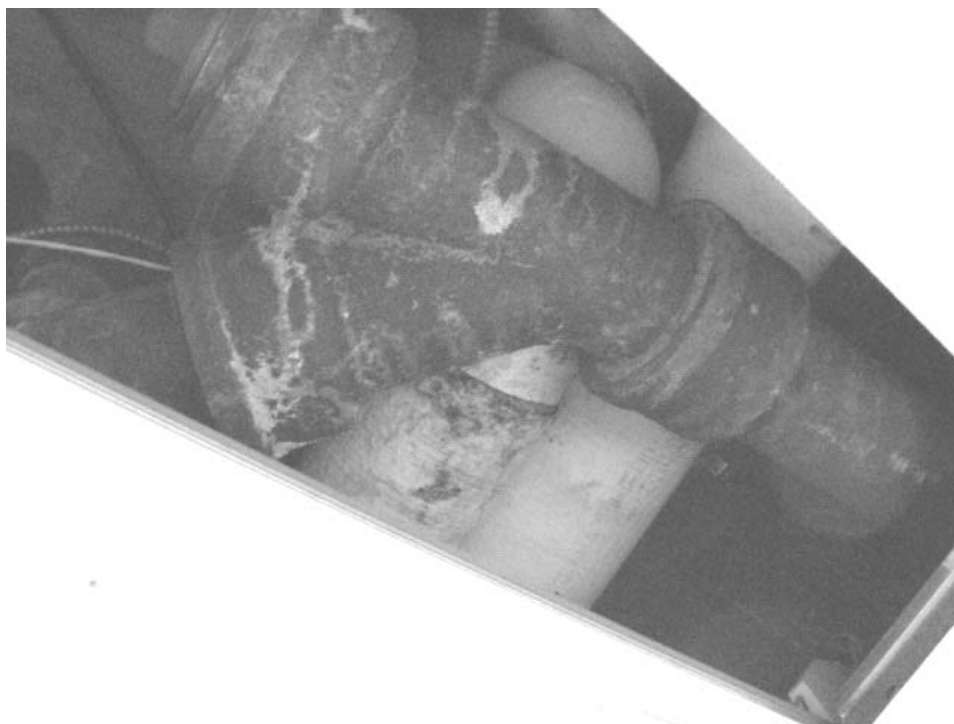
Picture 12

Water Damaged/Mold Colonized Pipe Insulation outside of Room 330

6. Re-wrap water-damaged pipe insulation above ceiling tiles.
7. Re-wrap exposed pipe insulation for rooftop AHU to prevent damage and potential flooding.

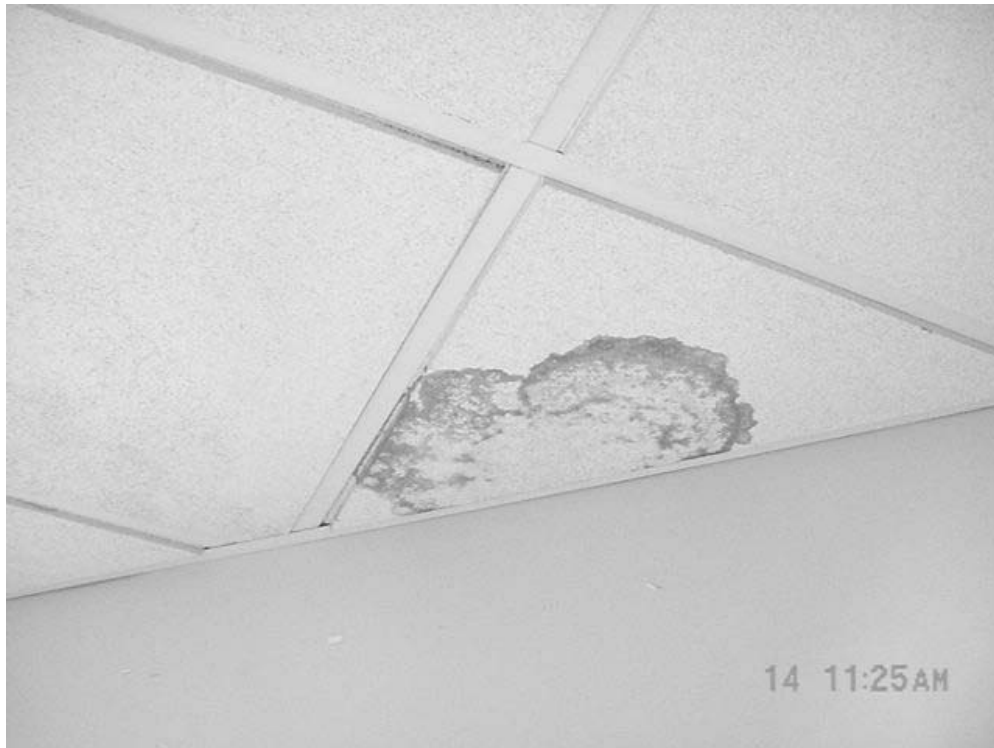
Picture 13

Water Damaged/Mold Colonized Ceiling Tile in the DA's Support Area

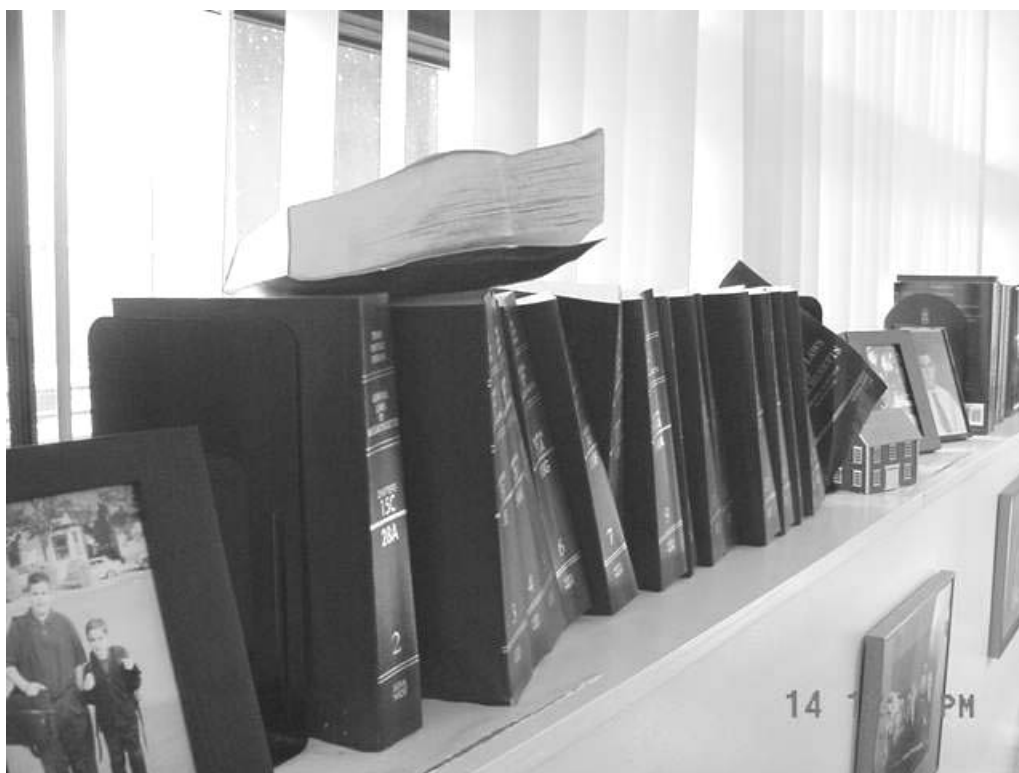
Picture 15

- Bottom of a book on the windowsill of room 165 (Picture 15);
- Cardboard folders and paper files in a file cabinet in storeroom 112 (Picture 16);
- Water-damaged newspaper beneath plants in the first floor office area (near fire alarm control door) (Picture 17); and on
- bottom of a wicker basket containing a plant in room 316 (Picture 18) (Tables 5 and 6).

Water Damaged/Mold Colonized Books in Room 165

5. Discard porous materials (e.g., boxes, papers, files) that are deemed unworthy of preservation, restoration or transfer to another media (e.g., microfiche or computer scanning). Where stored materials such as medical records are to be preserved, restored or otherwise handled, an evaluation should be conducted by a professional book/records conservator. The preservation/restoration process can be rather expensive and may be considered for conservation of irreplaceable documents that are colonized with mold. Due to cost of conservation, disposal or replacement of moldy materials may be the most economically feasible option.

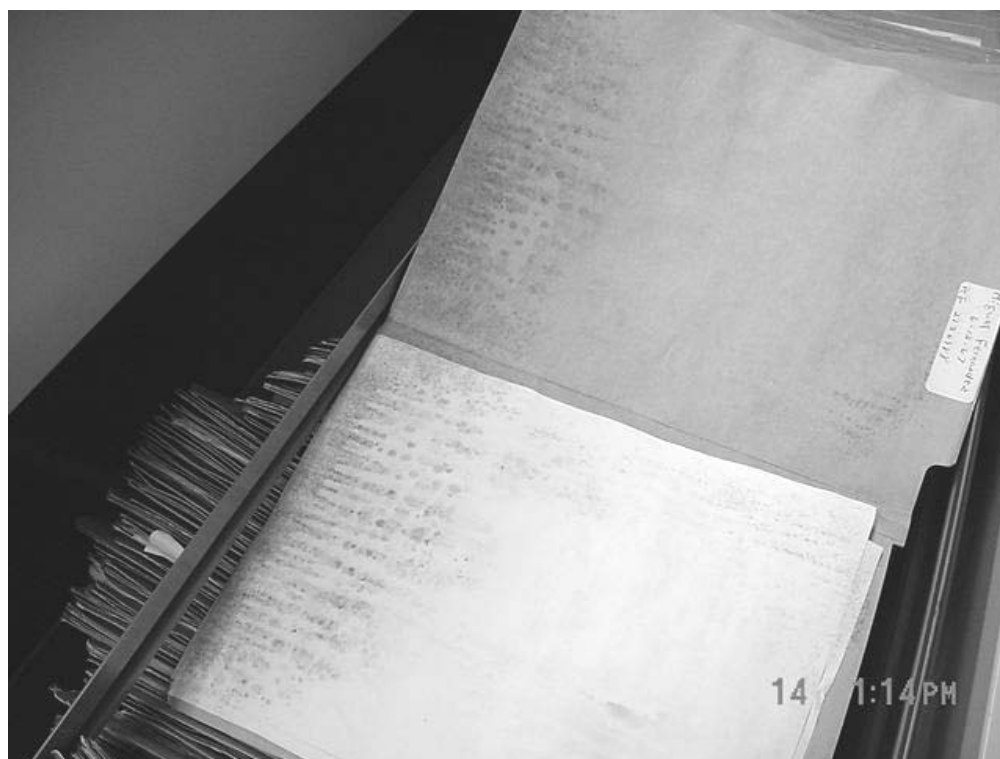
Picture 16

Water Damaged/Mold Colonized Files in Storeroom 112

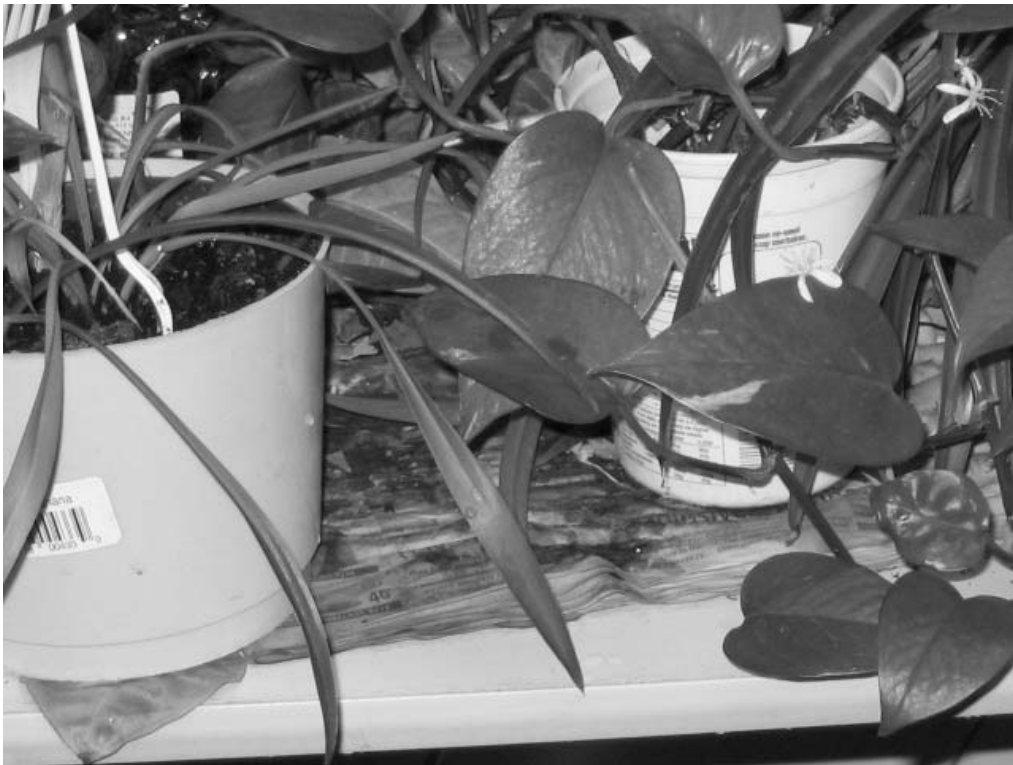
Picture 17

Water Damaged/Mold Colonized Newspapers under Plants in First Floor Work Station near Fire Control Panel

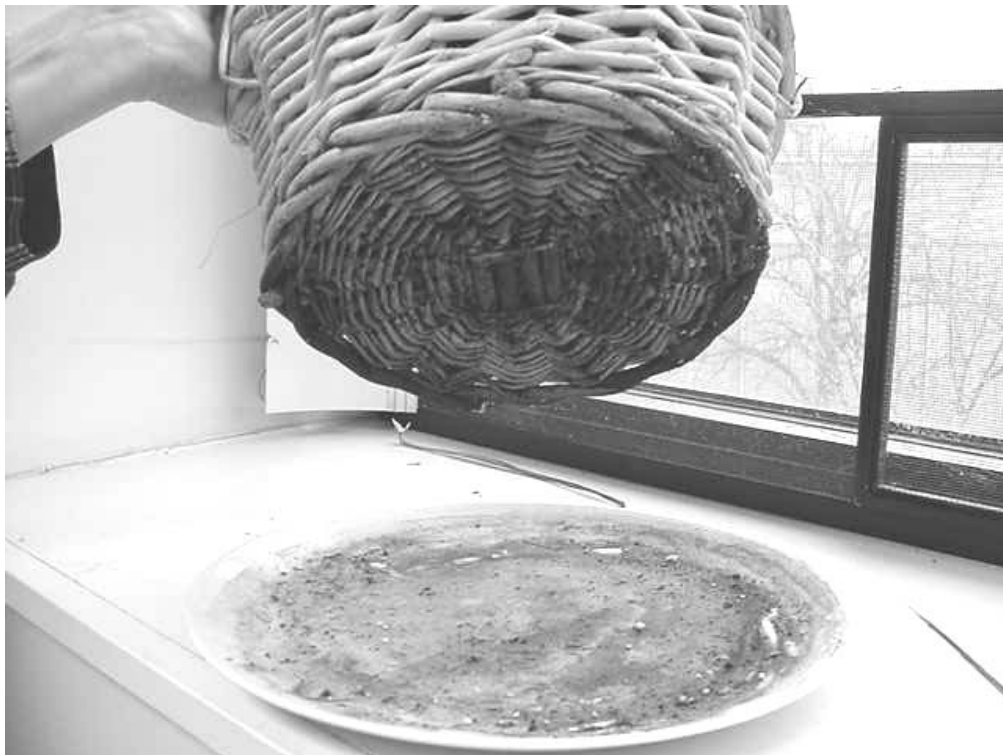
Picture 18

Bottom of Wicker Basket Containing Plant and Plate Serving as a Drip Pan on Windowsill in Room 316

7. Ensure all plants are equipped with drip pans that are made of a *non-porous* material. Examine drip pans for mold growth and disinfect areas of water leaks with an appropriate antimicrobial where necessary. Move plants away from ventilation sources. Consider reducing plants in some areas.

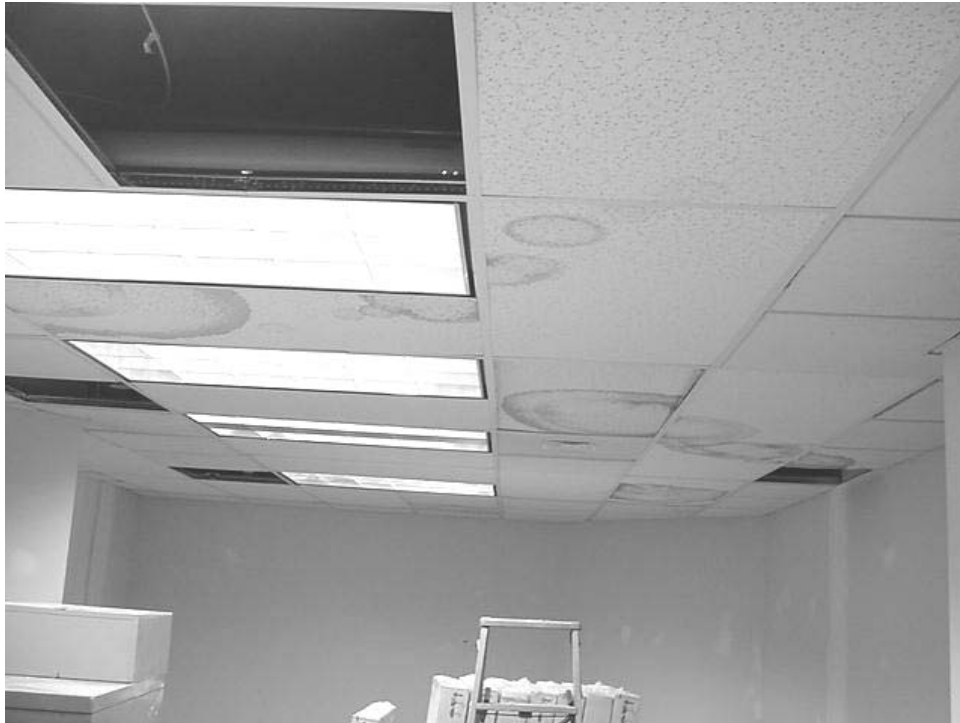
Picture 19

The RDC has a history of chronic roof leaks. Water-damaged ceiling tiles, pipe insulation above ceiling tiles and stains on walls were observed in areas throughout the building (Pictures 19 through 21). Water-damaged ceiling tiles can provide a source of mold and should be replaced after a water leak is discovered and repaired. Mr. Whitley reported that replacement of ceiling tiles at RDC is ongoing, particularly after wind-driven rain. CEH staff removed ceiling tiles in each of the rooms occupied by MDMH/RCC to examine the plenum above the tile system. Evidence of historic water penetration and leaks from HVAC equipment was observed.

Water Damaged/Missing Ceiling Tiles in Records Storeroom

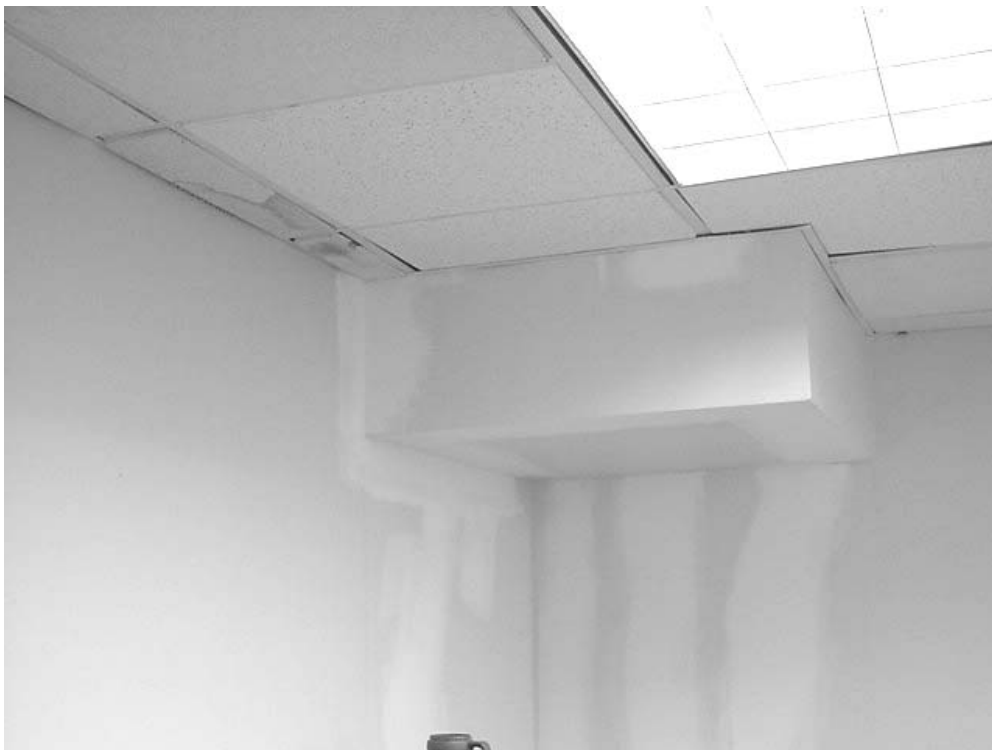
Picture 20

Water Damaged Ceiling Tiles and Gypsum Wallboard in Room 314, Note Light Areas Indicate Repairs Made to Water Damaged Materials

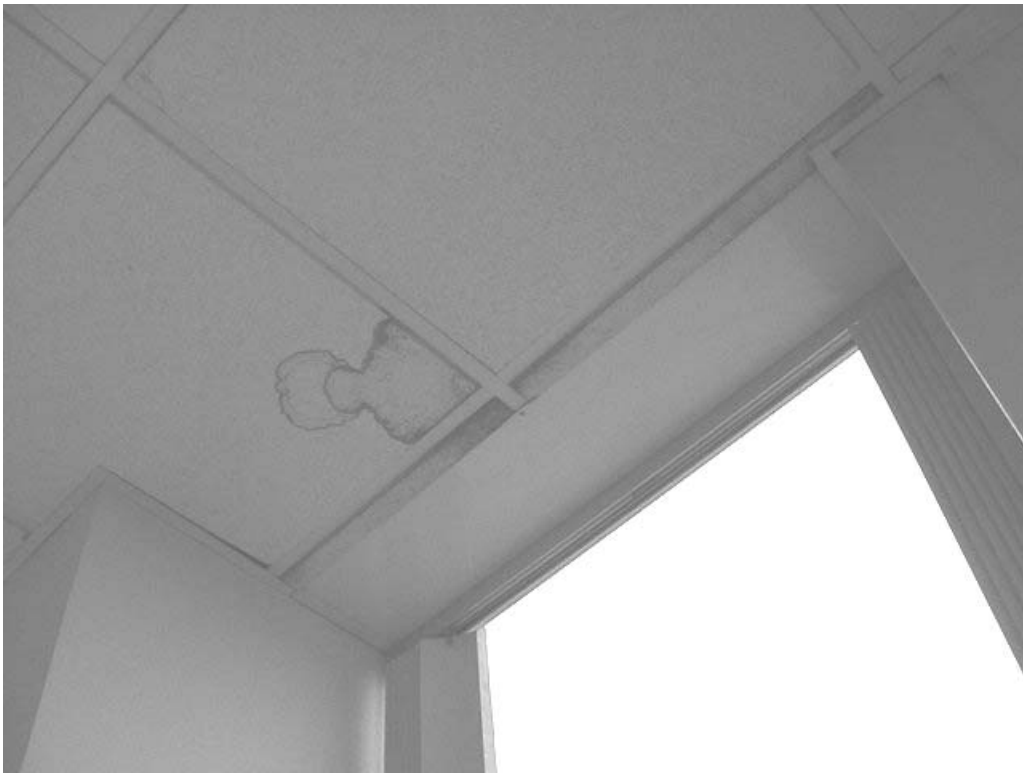
Picture 21

Water Damaged Ceiling Tiles in Room 316

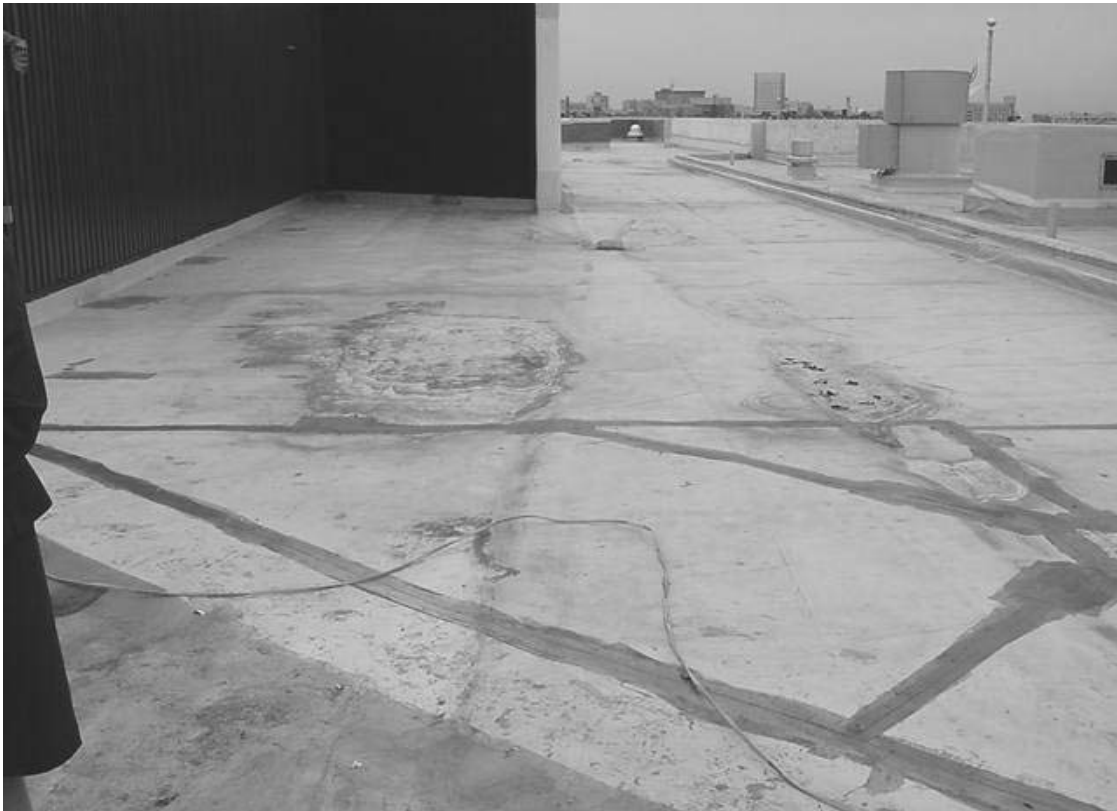
Picture 22

Several portions of the roof have been replaced and or repaired over the years, as was evident from the number of patches observed (Picture 22 and 23). CEH staff observed conditions on the roof and found the surface to be loose, rippled and uneven, creating divots and humps in a large number of areas. Water pooling in these areas followed by subsequent freezing and thawing of water during winter months can lead to roof leaks and related water penetration into the interior of the building. Pooling water can also become stagnant, which can lead to unpleasant odors and microbial growth. In addition, stagnant pools of water can serve as a breeding ground for mosquitoes.

Uneven Roof Surface, Note Patches on Seams Indicated by Dark Material on Roof Deck

1. Continue with plans to replace roof and conduct building envelope survey. Make any needed repairs to building envelope to prevent water infiltration and subsequent water damage.
2. Continue to monitor for active leaks roof leaks. Building occupants should notify the Court Facilities Bureau if leaks are observed for prompt action.
3. Continue working with roofing contractor in making roof repairs/patches as needed to prevent further water penetration.
4. Refrain from storing porous materials in areas of current and/or chronic leaks.
5. Ensure that measures to dry building materials (e.g., fans and/or heating) are taken for future flooding/heavy water damage are made in accordance with US EPA and ACGIH recommendations (e.g., within 24 to 48 hrs.) to prevent mold growth. In addition, vinyl coving should be removed to ensure complete drying of the base of walls.

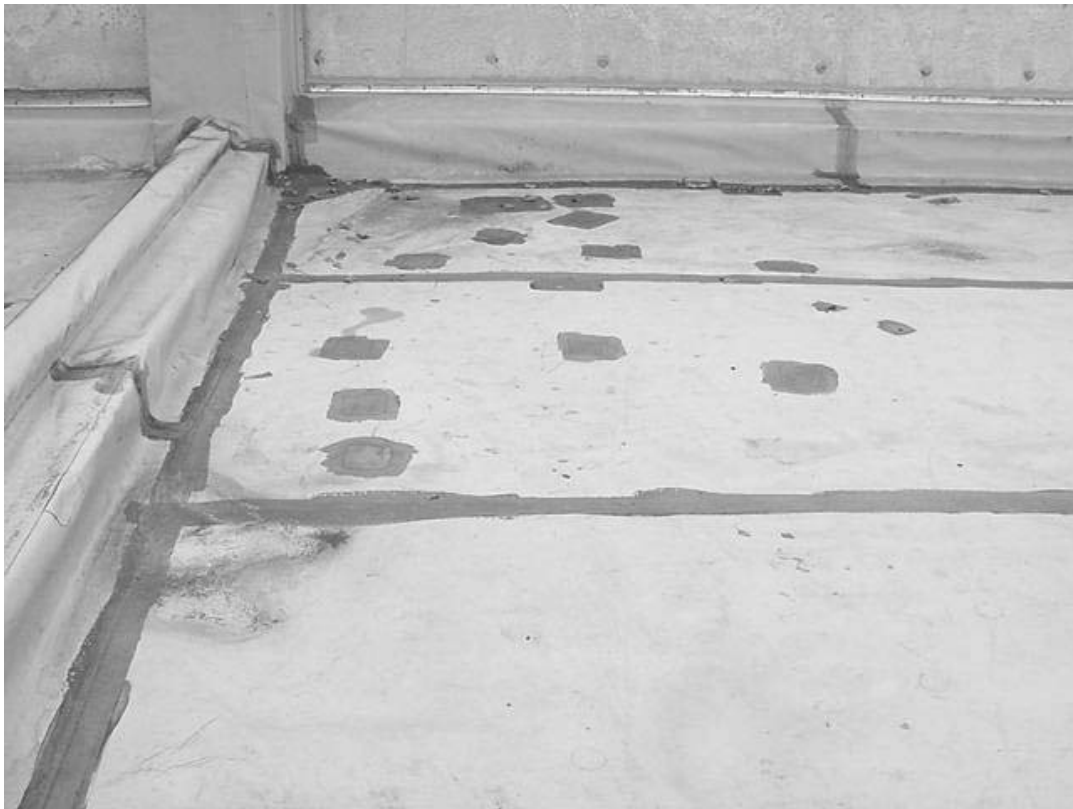
Picture 23

Patches Indicated by Dark Material on Roof Deck

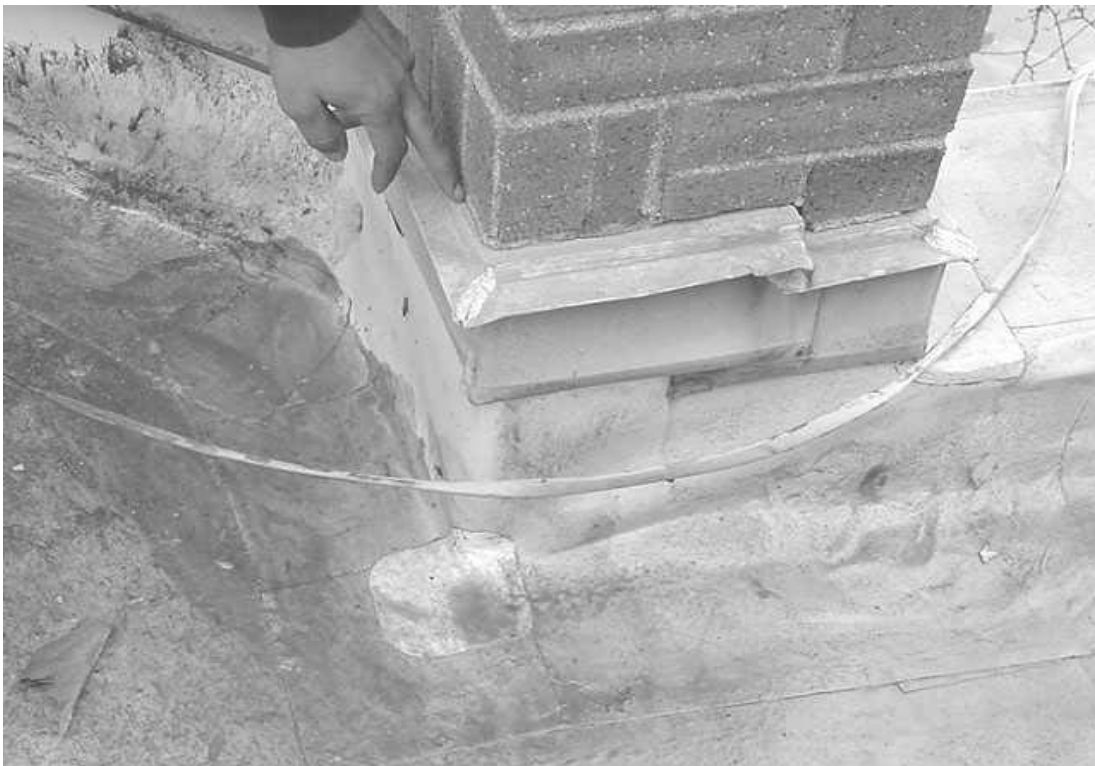
Picture 24

Mr. Whitley also reported that other measures to prevent leaks in the building have been attempted, such as caulking around roof seams and windows, replacing roof flashing (Picture 24), repointing of exterior brickwork, and sealing of roof penetrations around HVAC equipment and utilities (Pictures 25 and 26). Mr. Lane and Ms. McSweeney reported that the Division of Capital Asset Management (DCAM) has committed to capital funds to conduct a comprehensive building envelope study as well as replacement of the roof. In the interim, attempts are

Repairs Made to Roof Flashing

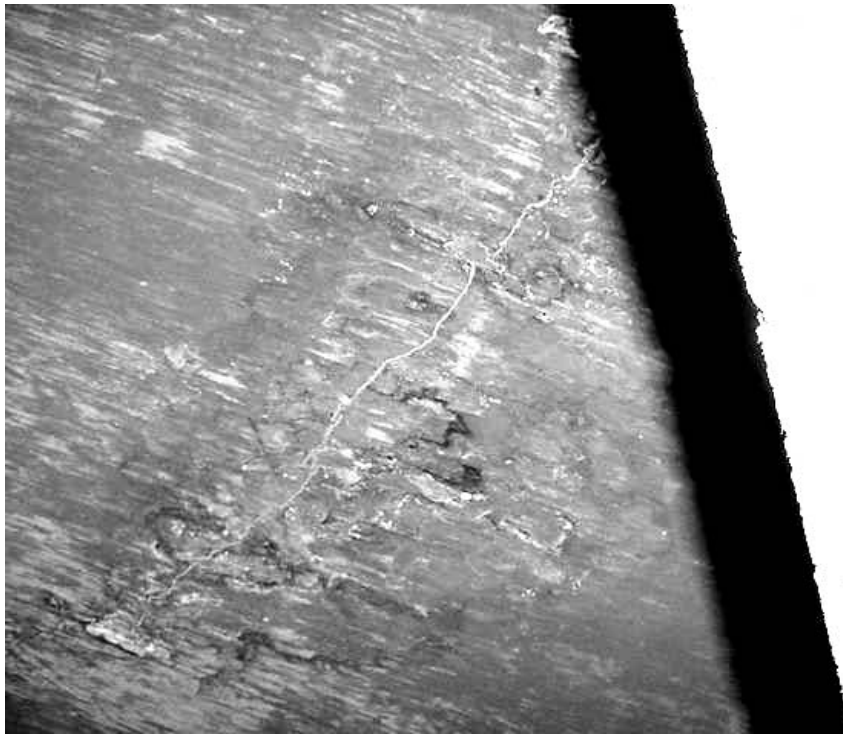
Picture 27

An examination of the underside of the roof decking in a MDMH/RCC storage room revealed a series of holes for roof drains and hairline cracks in cast cement that have either rust stains or efflorescence (Pictures 27 to 29). Efflorescence is a characteristic sign of water damage to brick and mortar, but it is not mold growth. As moisture penetrates and works its way through mortar and brick, water-soluble compounds in mortar and brick dissolve, creating a solution. As the solution moves to the surface of the mortar or brick, the water evaporates, leaving behind white, powdery mineral deposits. Efflorescence on the underside of a coast stone deck is an indication of chronic water leaks created by the damaged roof membrane.

Rust Stains and efflorescence, roof deck above MDMH store room

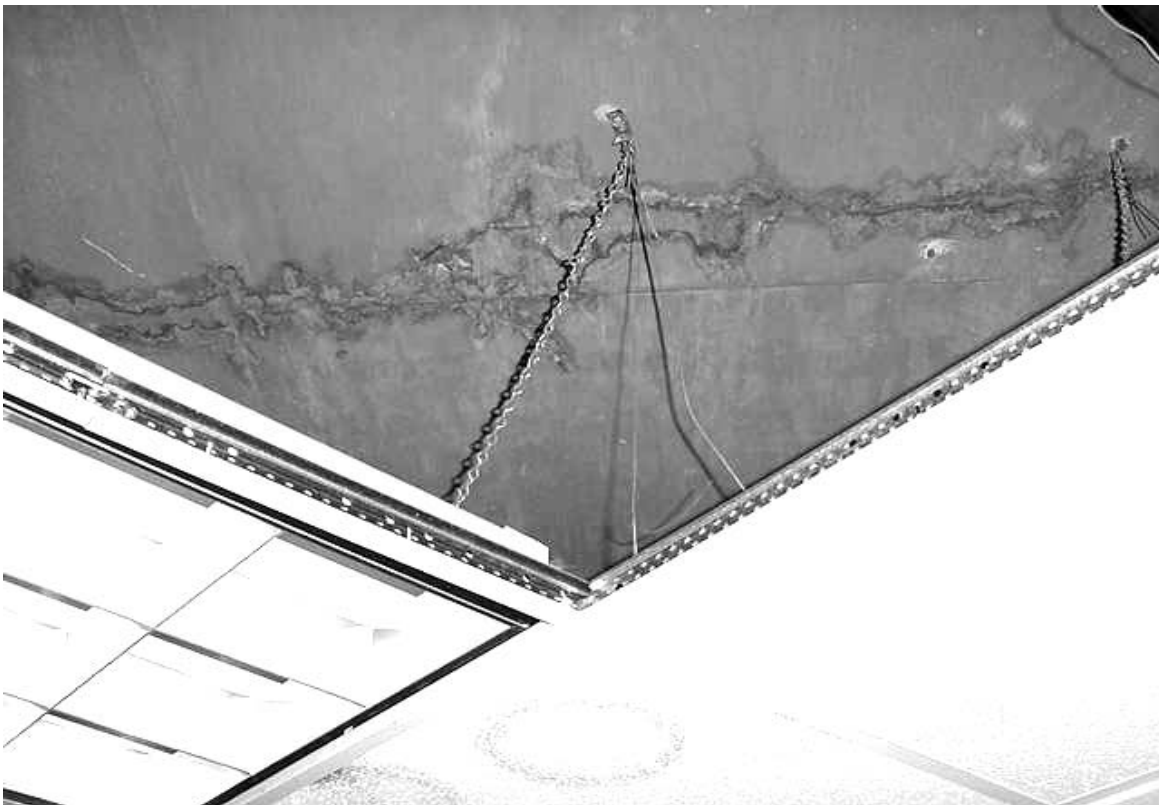
Picture 28

Rust Stains and efflorescence, roof deck above MDMH store room

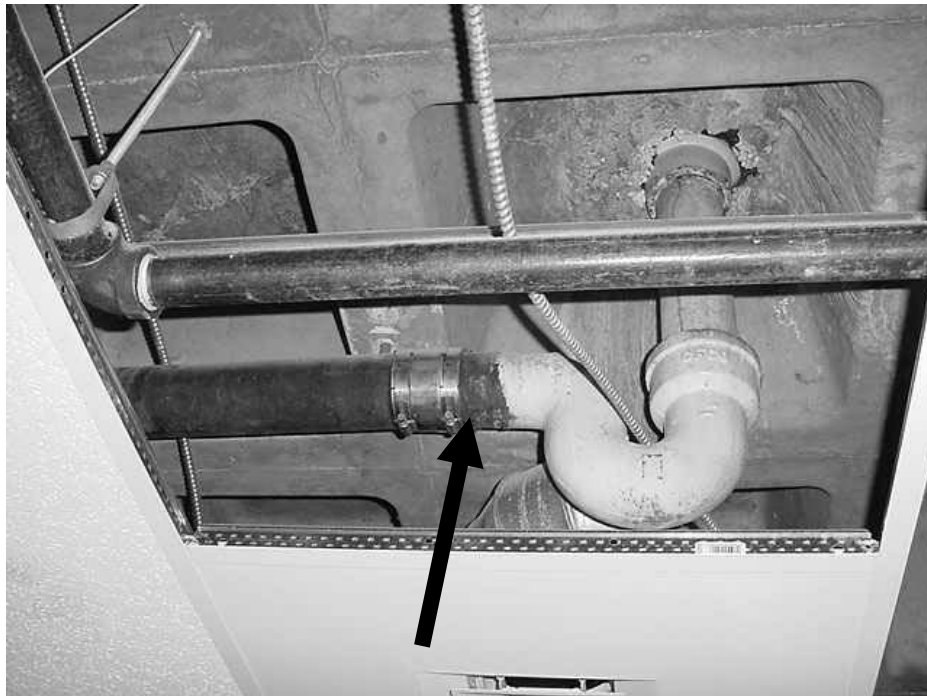
Picture 29

Water damage to roof decking around roof drain, roof deck above MDMH store room, Note Corrosion on joint held in place by rubber gasket screw clamp (see arrow)

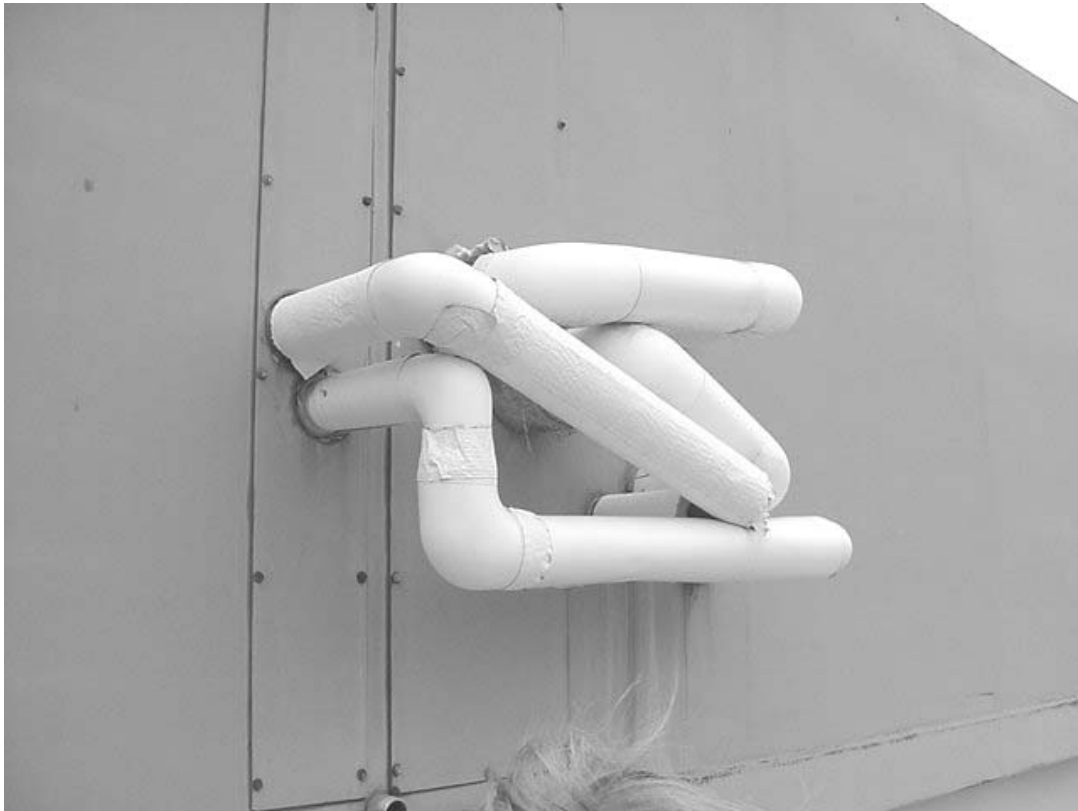
Picture 30

In addition to chronic roof leaks, Mr. Whitley reported that during the winter of 2005, heating pipes connected to the rooftop AHU (Picture 30) froze, resulting in flooding to the MDMH/RCC offices for approximately three hours. Carpets were reportedly cleaned with an extractor to remove moisture, shampooed several times and dried with floor fans. The flooding also resulted in water-damaged ceiling tiles, pipe insulation, and gypsum wallboard (GW). Although efforts were made to clean and dry carpeting, vinyl coving at the base of walls was not removed. Vinyl coving serves as an impermeable barrier that traps moisture behind it, preventing GW from drying. CEH staff removed the coving in some areas and observed mold growth. Upon closer examination, CEH staff also noted sections of the pipe were not completely insulated and exposed to the elements (Picture 31). Pipes should be fully insulated to prevent the future occurrence of freezing.

AHU Heating Pipes That Froze over the winter of 2005

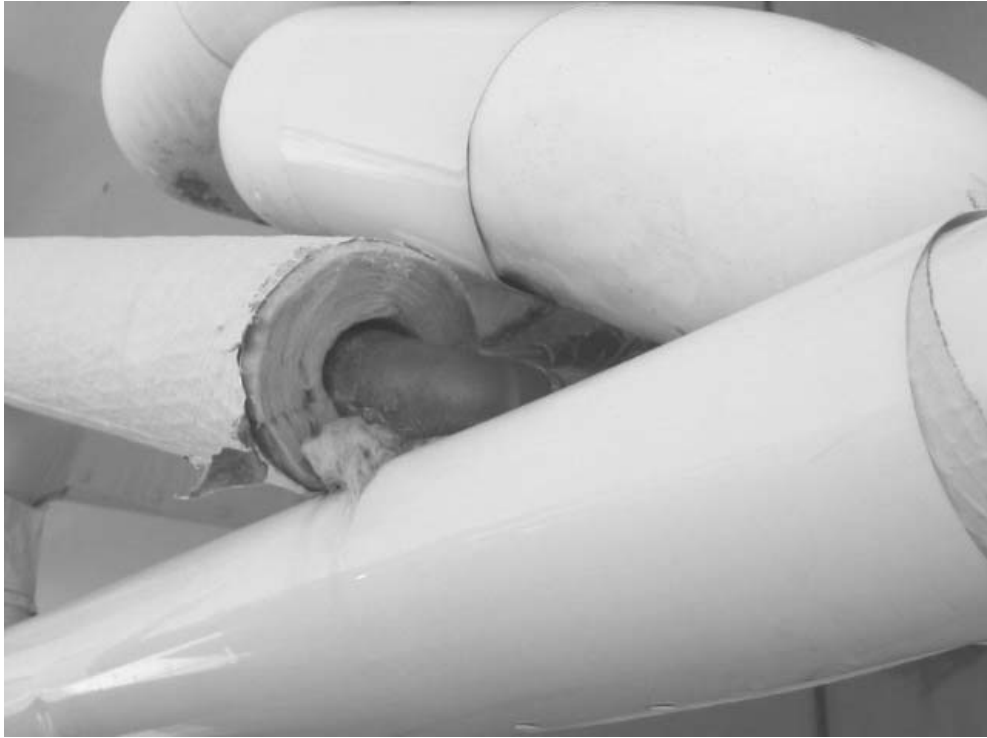
Picture 31

Close-Up of Exposed AHU Heating Pipes Shown in Preceding Picture

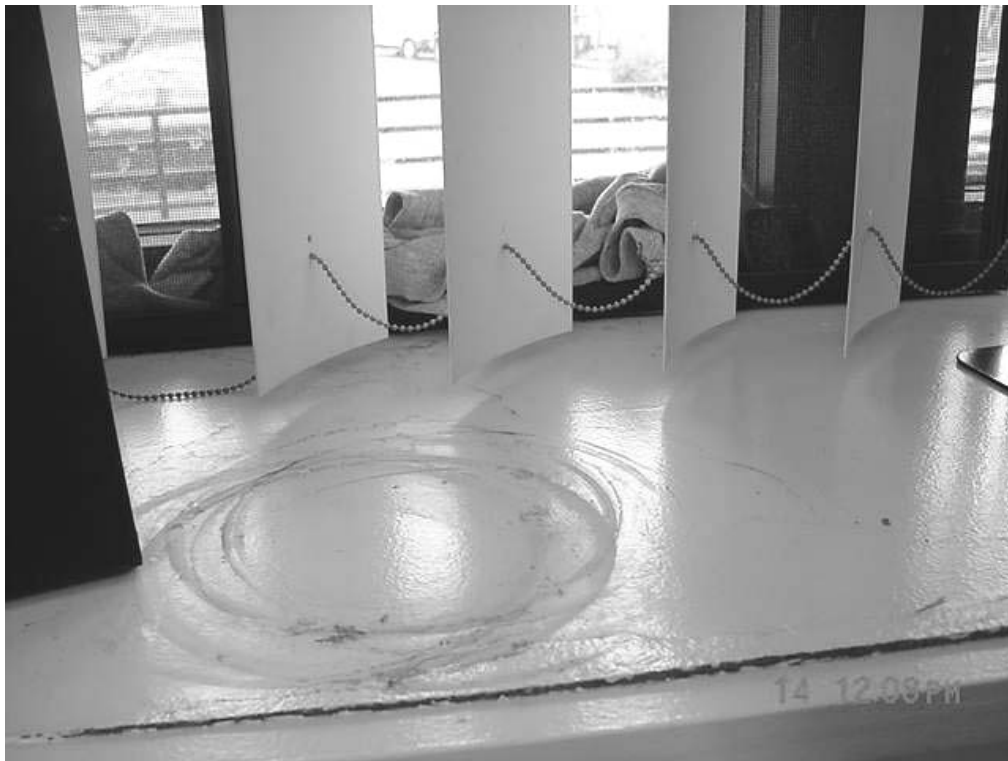
Picture 32

- Water penetrating through the western exterior wall window system (Picture 32);
- Water accumulating behind spandrels of the northeast-facing exterior wall;
- Water penetrating the exhaust system ductwork in the MDMH/RCC offices;
- Water traveling from the roof along the exterior surface of roof drain pipes;
- Water leaking from plumbing systems inside the building; and
- Condensation dripping from chilled water pipes when the HVAC system is operating in the air-conditioning mode during warm weather.

Water Damaged Wooden Windowsill on First Floor (Rear), Note Cloth Stuffed Between Window Pane to Absorb Moisture

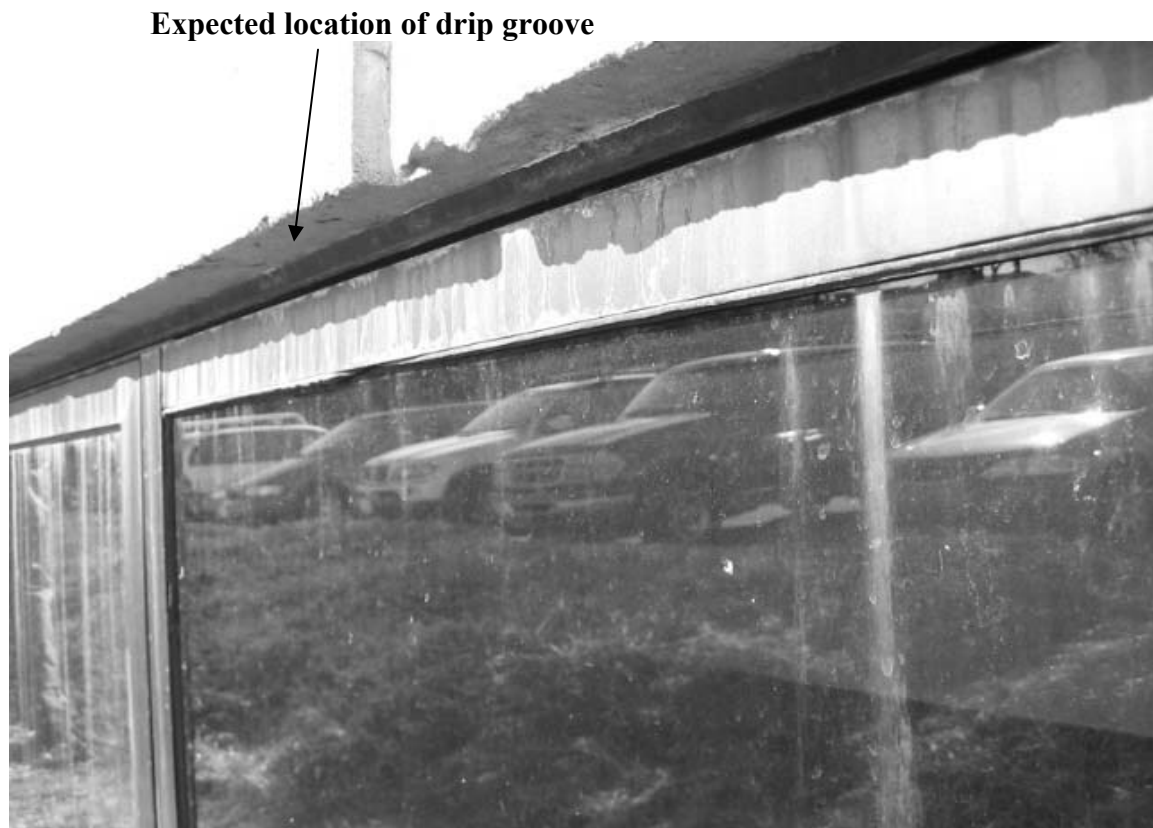
Picture 33

The western exterior wall of the RDC consists of a glass and metal window frame system that is installed in the cement curtain wall. Window frames and glass appear to be stained with efflorescence (Picture 33), indicating exposure to a solution of water soluble salts resulting from rainwater against the curtain wall cement. This solution is likely alkaline, which can damage window gaskets and caulking, as well as wall sealant used to render expansion joint weathertight. In order to prevent water exposure to windows, builders typically install a drip groove in the stone/cement wall above window frames. As rainwater rolls down the exterior wall, water droplets encounter the drip groove, which directs water to drip downward instead of into the window area itself. No groove edge could be identified for any window in the western exterior wall (Picture 33). In this condition, deterioration of rubber gaskets and caulking could be

accelerated, creating holes through which water may penetrate and moisten interior building components and/or materials stored on windowsills.

Efflorescence staining West Wall Window system, no lack of drip groove above window

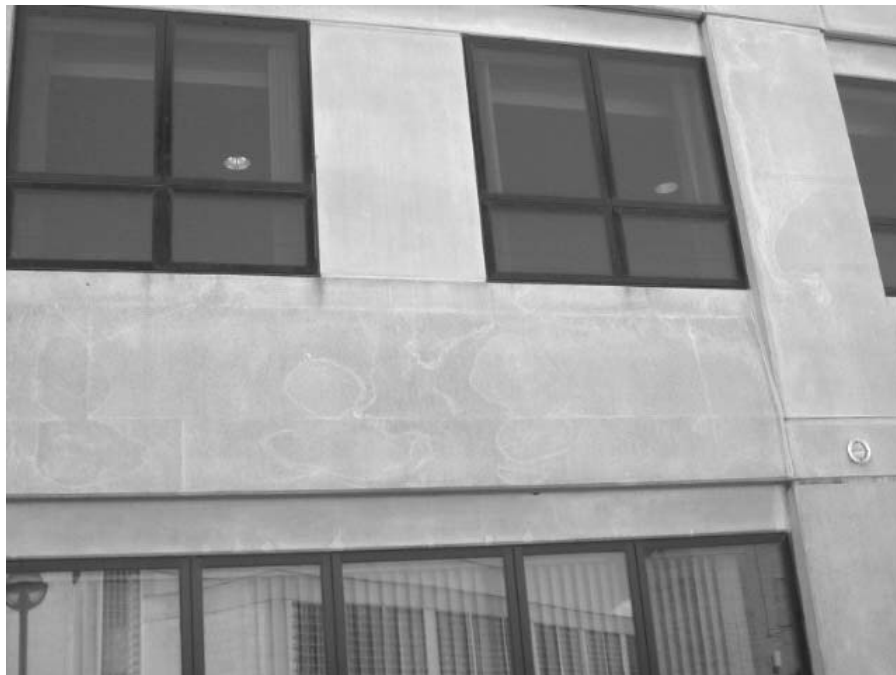
Picture 34a

The northeast facing exterior wall consists of a window/stone panel system. Of note are the stone panels, which appear to be constructed from cementitious materials (34a and 35a). The wall panels were mottled with stains, indicating water damage (34b and 35b). CEH staff examined these panels and could not locate weep holes. Weep holes are designed to provide for water drainage.

Exterior Wall Panel Northeast wall

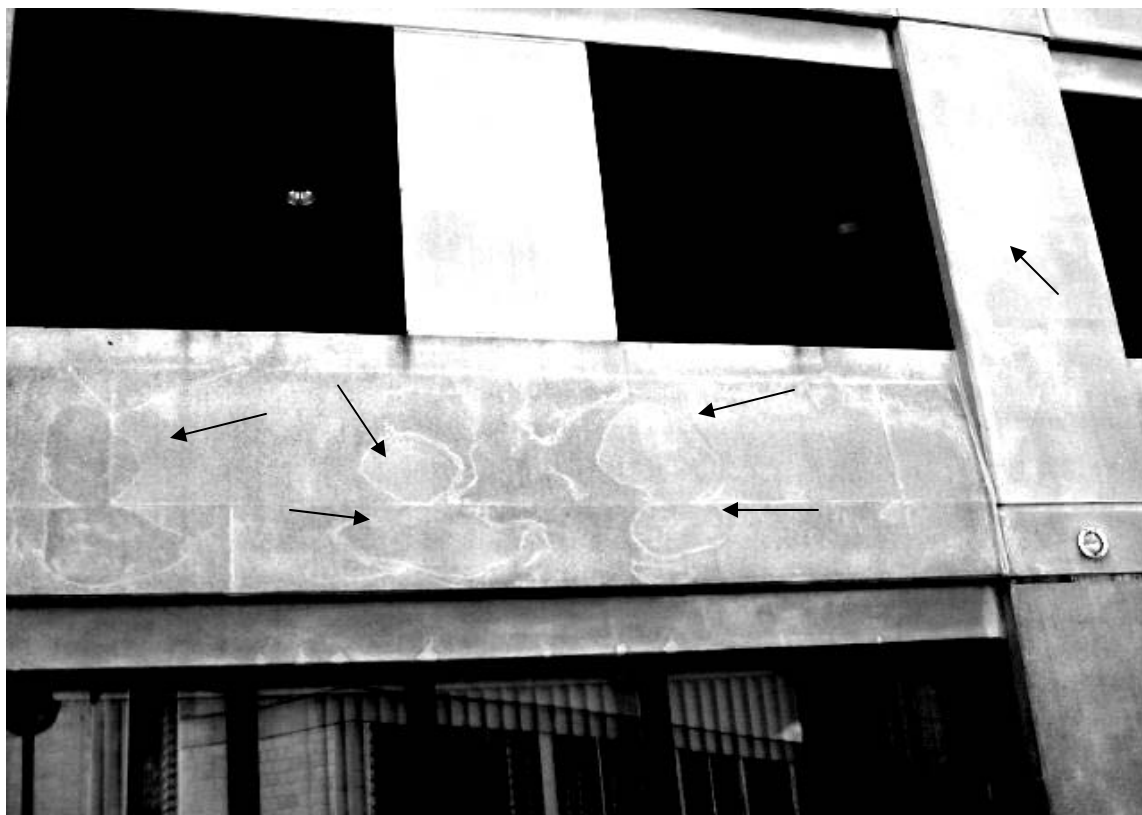
Picture 34b

Picture 33a with contrast altered, revealing water stain patterns on exterior wall panels (Arrows)

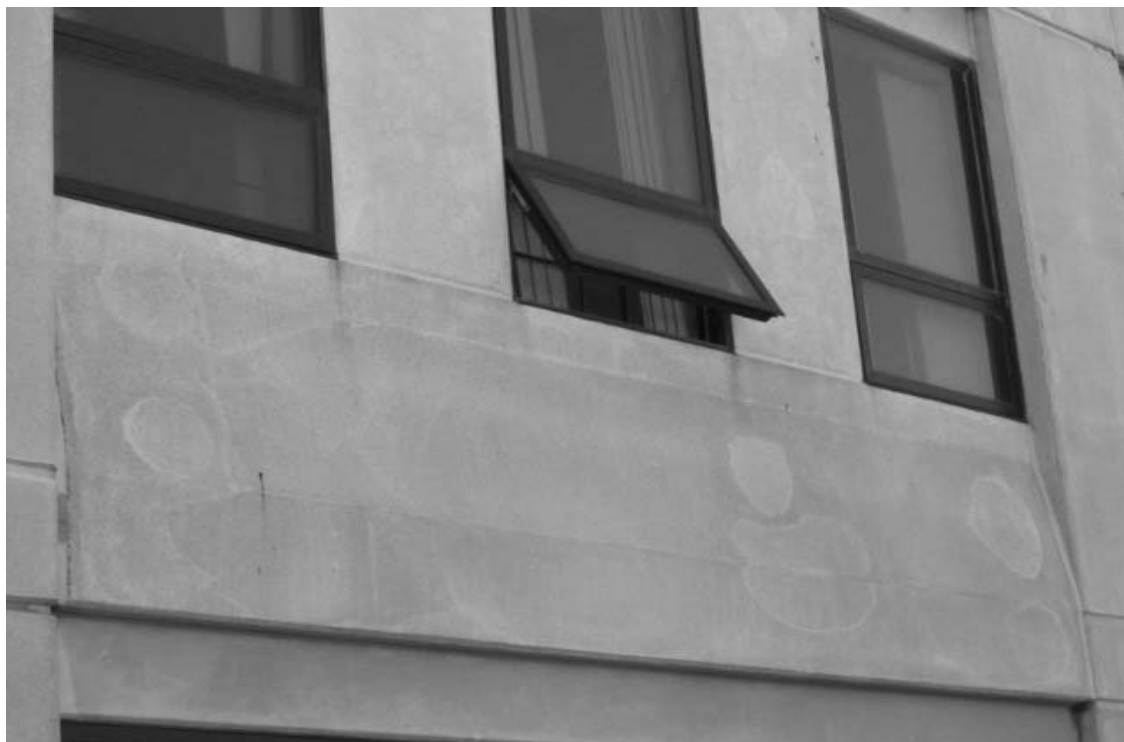
Picture 35a

Exterior Wall Panel Northeast wall
